# **USED LUBE OIL ANALYSIS & ANALYTICAL FERROGRAPHY**

Paul Goldman  
MRT Laboratories  
305 Nebraska Ave  
South Houston, TX 77587

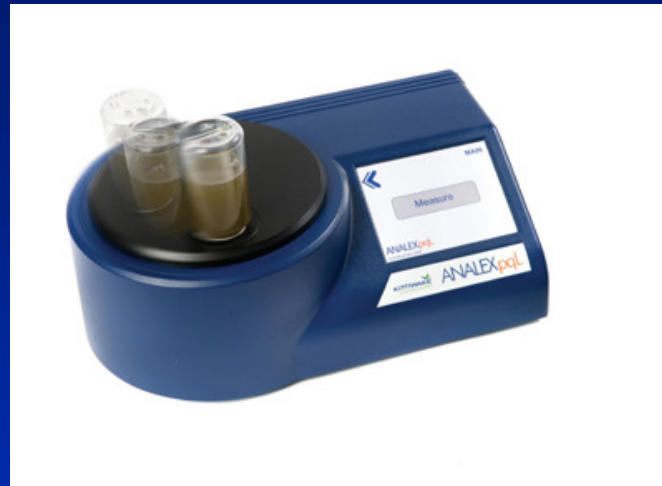
### Analex's PQL Ferrous Debris Monitor

A magnetometer that measures the mass of ferro-magnetic debris in a sample and displays this as a PQ (Particle Quantifier) index.

The PQ Index is a quantitative unitless number ranging from 0 to 5000

Independent of particle size

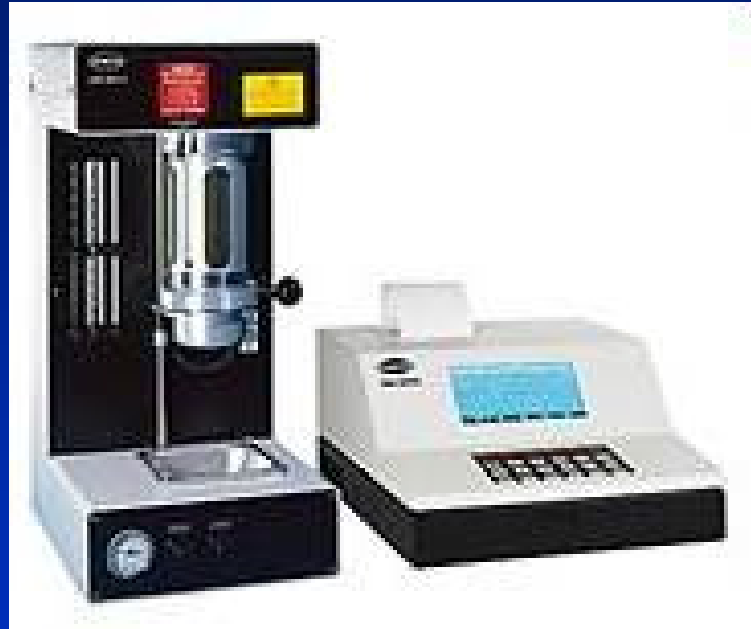
**Determines Cleanliness of Lubricant and Other Fluids  
by measuring scattered laser light.**

**Reported at 4, 6, 14 micron thresholds (ISO 4406.1999)**

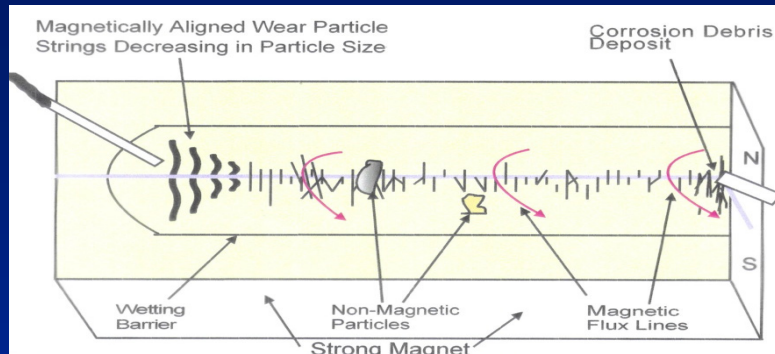
**Ferrogram is made on Slide Maker**

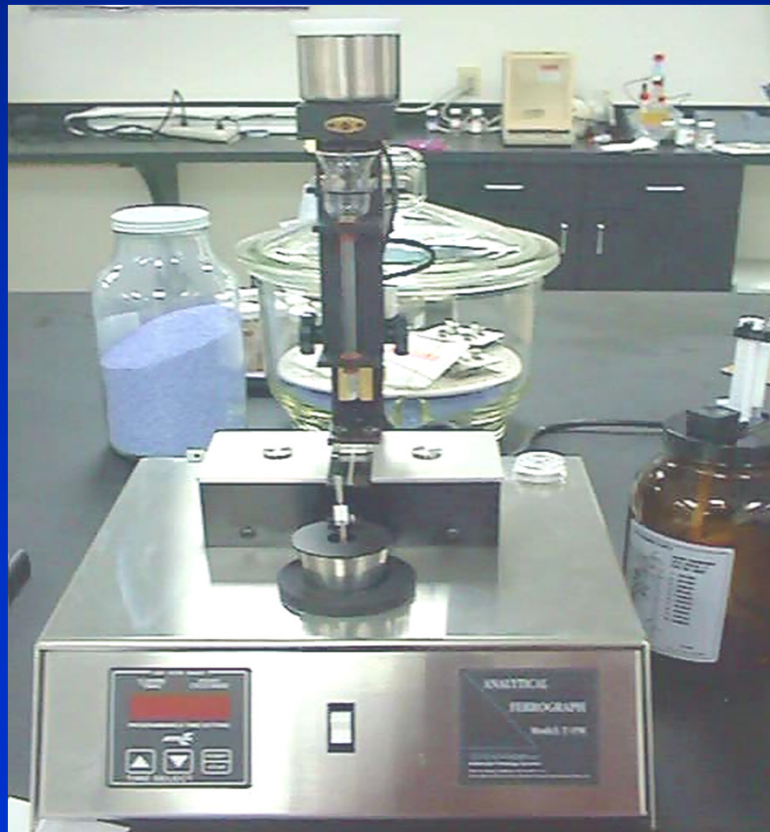
**Slide is washed with heptane that has been triple filtered through a .45 micron filter. This removes oil residue.**

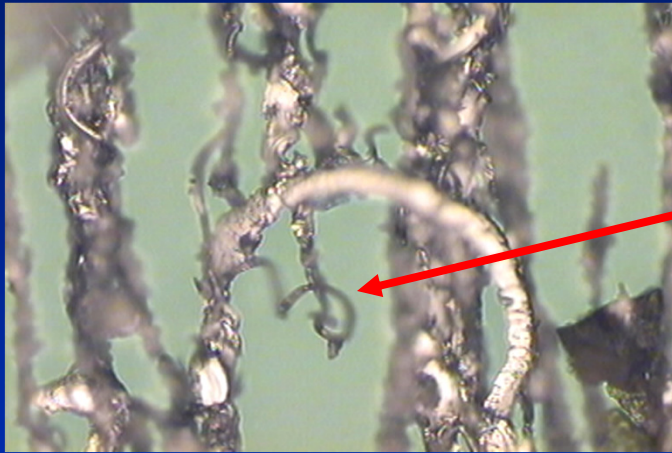
## LARGE CUTTING WEAR

Large, curled cutting wear particles such as this are usually generated as a result of misalignment or abrasive particle embedded in a Babbitt bearing.

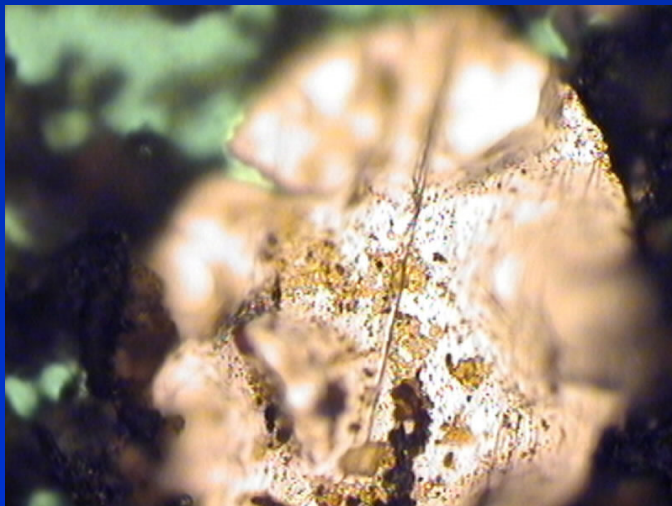
## LARGE LAMINAR PARTICLES

Large, rounded, flat particles with a width/thickness ratio of 20-1 are generated as a result of rolling element fatigue. Macro-spalling is indicated if the particles are in the 40 micron size range.

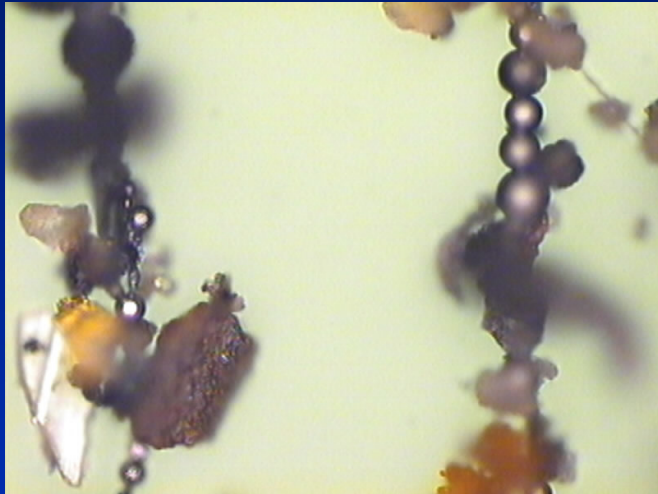
## FATIGUE CRACK SPHERES

Fatigue cracks can generate small 1-10 micron spherical particles, sometimes copious amounts.

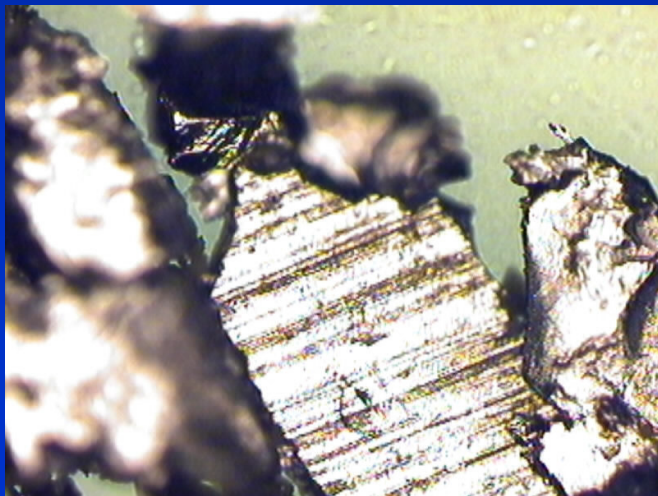
## GEAR ROOT OR TIP WEAR

### Severe Sliding Wear

Gear root or tip wear generates long, flat particles, often with striation marks as a result of the sliding that occurred during generation.

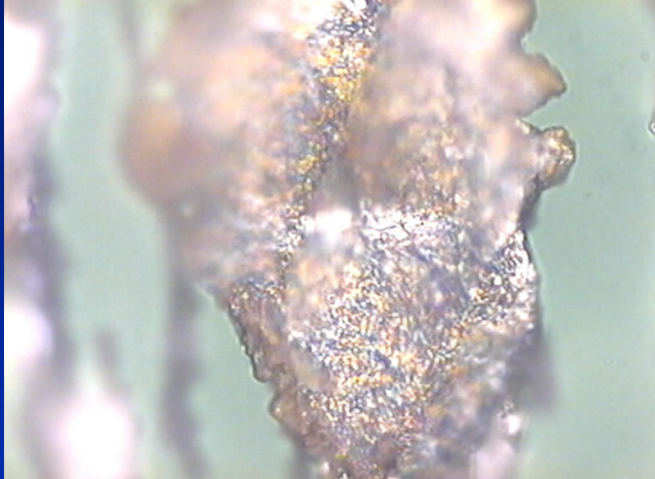
## BABBITT PARTICLES

Babbitt particles can be identified by their stippled, multicolored surfaces.

Their edges will often melt slightly when heated to 625° F

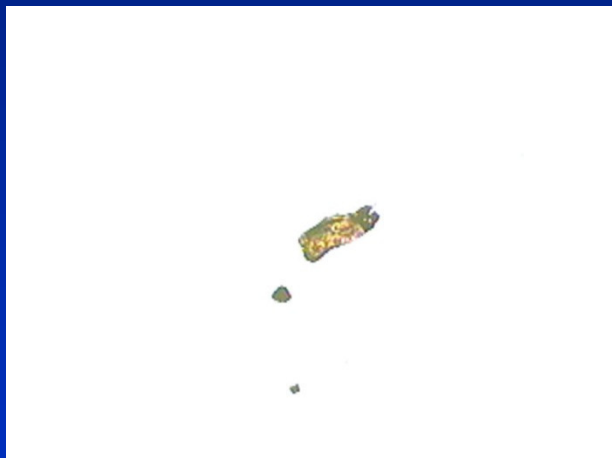
## **100X Magnification**

**At 100X, it can be determined this 500 micron particle is significant**

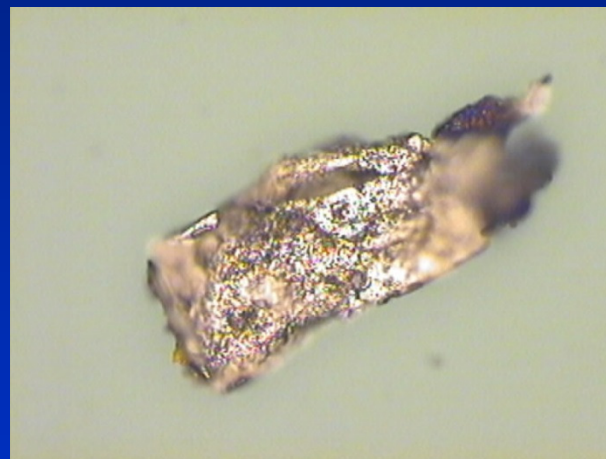
## **500X Magnification**

**At 500X, details of the particle and its morphology become more evident.**

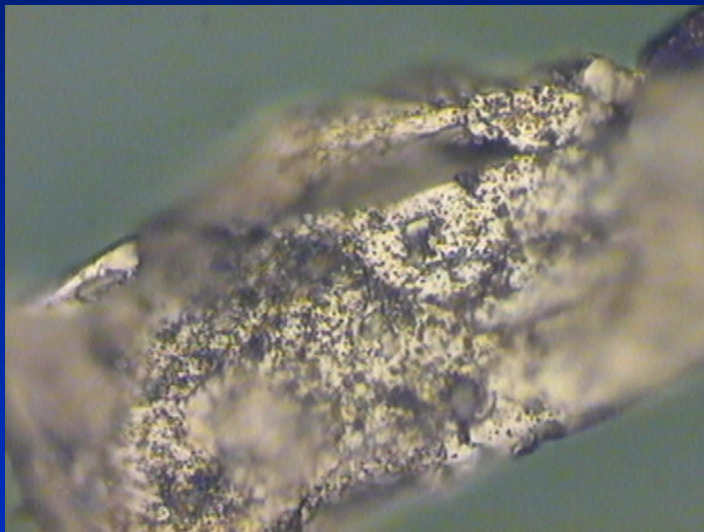
## 1000X Magnification

**At 1000X, minute details of the particle can be observed.**

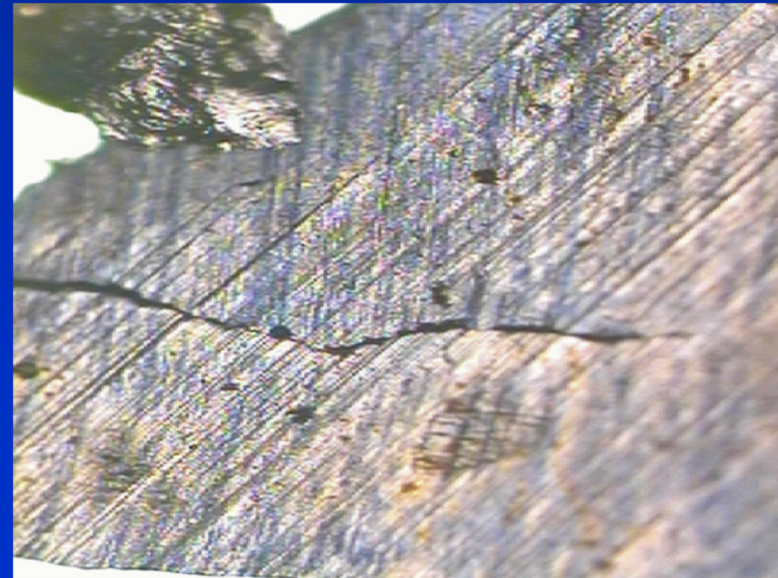
**Much larger carbon steel particles will only turn slightly blue unless heated for a longer period of time.**

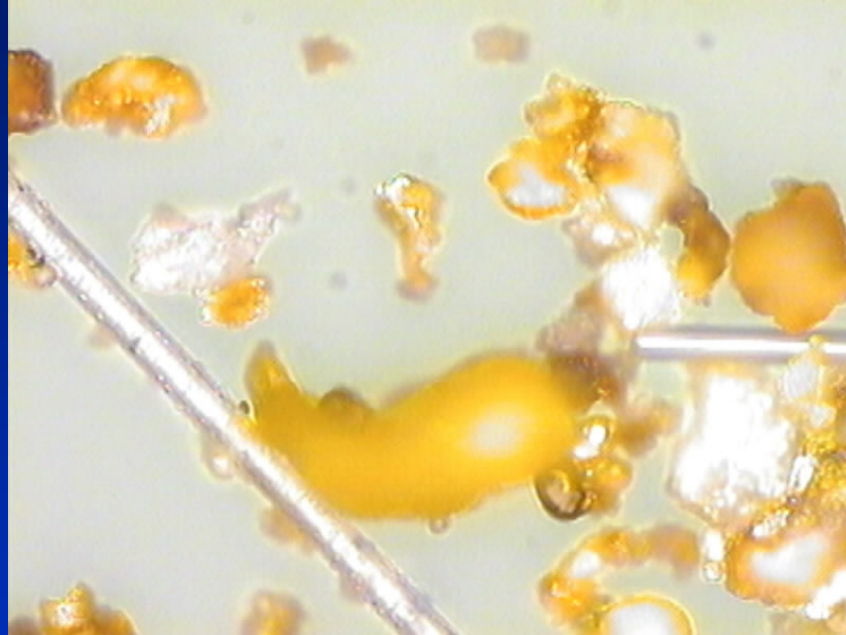
**Rust particles will turn bright reddish/orange as they are heated. Heating will have no effect on fiberglass debris from filters. This is one method of identifying fibrous material.**

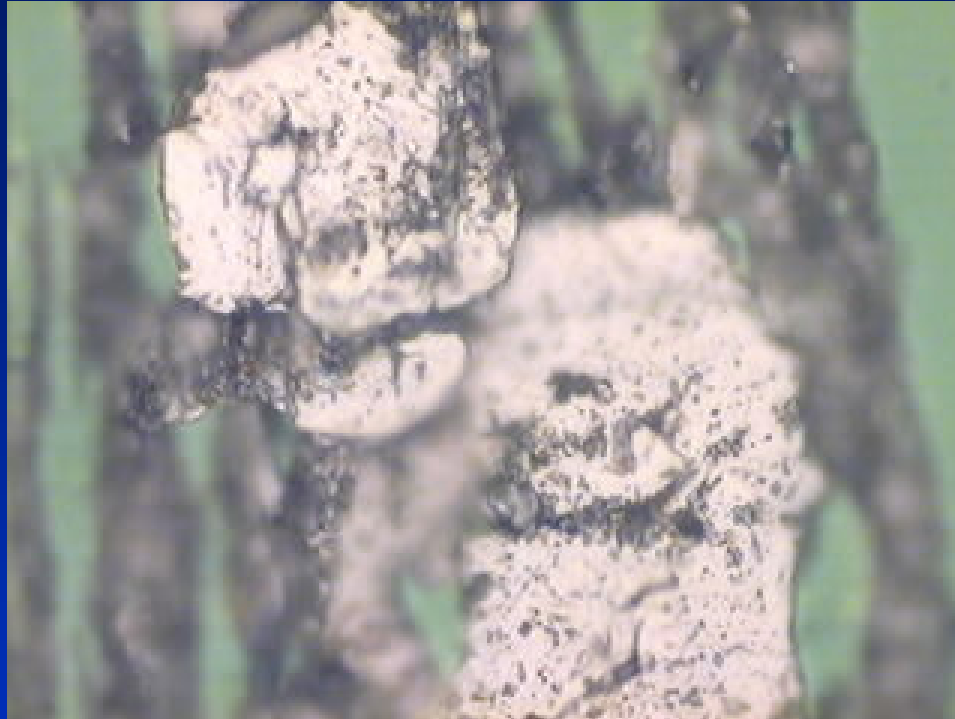
**500X – heavy spalling from roller bearing element.**

**When heated to 625f for 120 seconds, these turned blue, indicating carbon steel.**

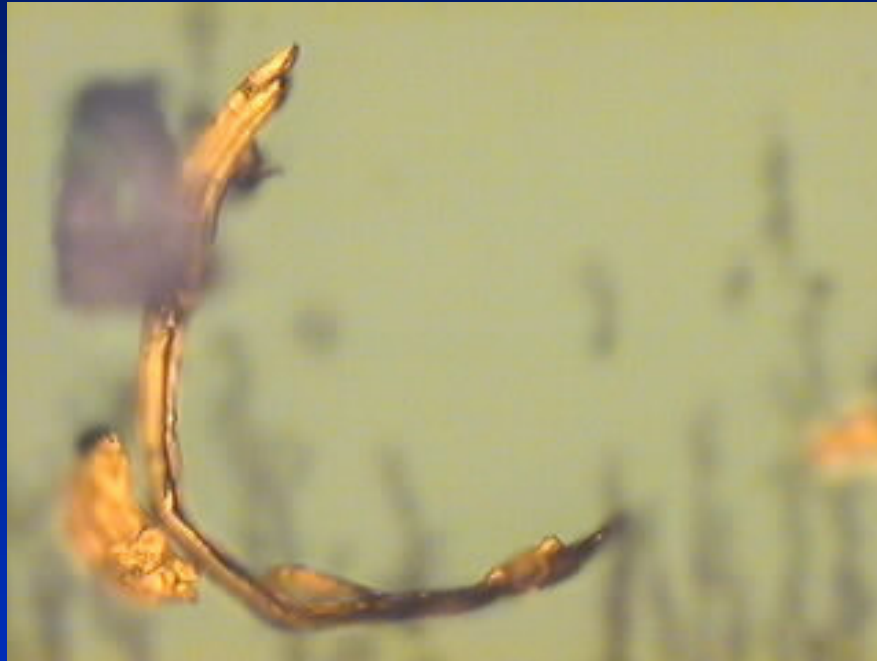
**100X – Wear from a slinger ring.**
